## The Use of Glass-Ceramic Crowns to Enhance Smile

Omar El-Mowafy, The Use of Glass-Ceramic Crowns to Enhance Smile. Jour of Clin and Medi Images® 2026; V9(1): 1-6

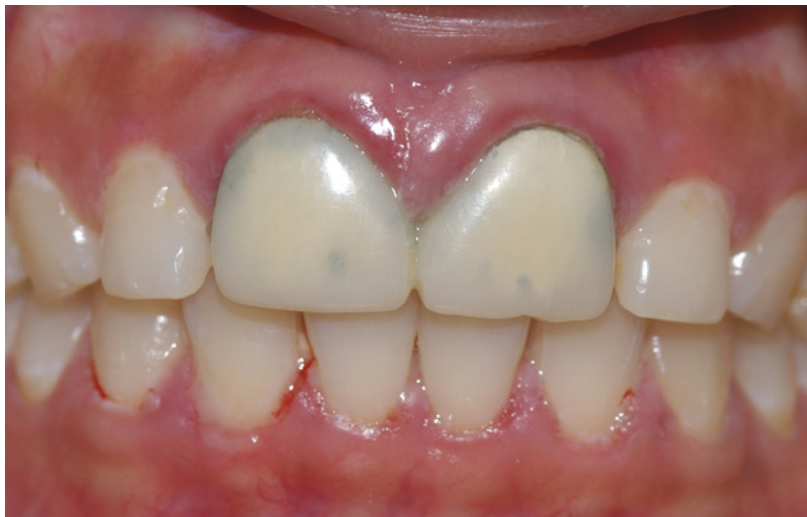
**Figure 1:** Upper central incisors of a young female presenting with suboptimal full ferrometal crowns. The underlying metal copings are visible through the thin veneering porcelain, compromising aesthetics. The surrounding gingival tissues exhibit signs of gingivitis and edema, likely associated with adverse tissue response to the crowns. Additionally, the dimensions of the central incisors appear disproportionate when compared with those of the adjacent laterals.

The original cream-metal crowns were aesthetically unsatisfactory and were associated with gingival inflammation. The inflammatory response was most likely related to poorly adapted and rough crown margins that promoted plaque accumulation, although the contribution of the nonprecious alloy used cannot be completely excluded [11,12]. Furthermore, less than optimal oral hygiene condition of the patient adversely contributed to the gingival inflammation.

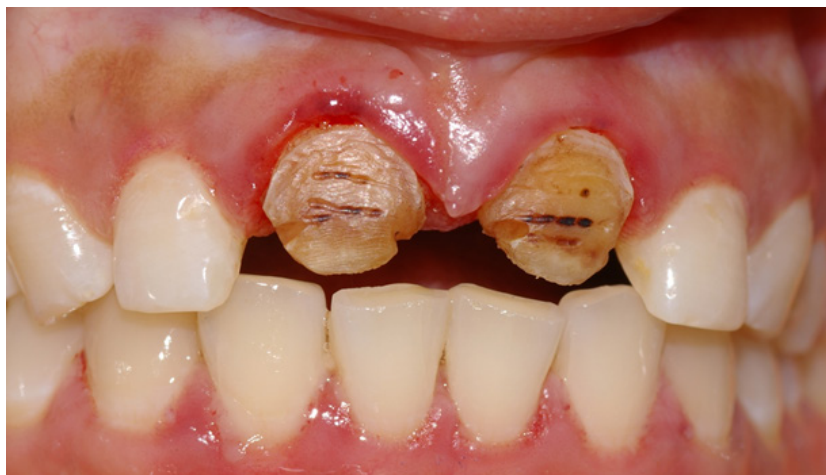
**Figure 2:** Appearance of the prepared upper central incisors after crown removal. The preparation design is suboptimal, with inadequate near parallelism of the axial walls, compromising mechanical retention. The preparations are also short. The gingival inflammation affecting both central incisors appears to be directly related to the crown margins.

Removal of the original crowns revealed unusual tooth preparations that lacked adequate retention form. Furthermore, the finish lines were poorly defined, particularly on the lingual surfaces. These findings indicate deficiencies in preparation design that compromised the mechanical retention of the crowns which were easily removed together without any drilling with a manual crown remover. Successful crown preparations require two essential features: near-parallel axial walls and adequate occlusogingival height [13-17]. Both features were deficient in the original preparations. Careful modification of the preparations without compromising the pulp established appropriate axial wall geometry and clearly defined finish lines, thereby improving retention and stability.

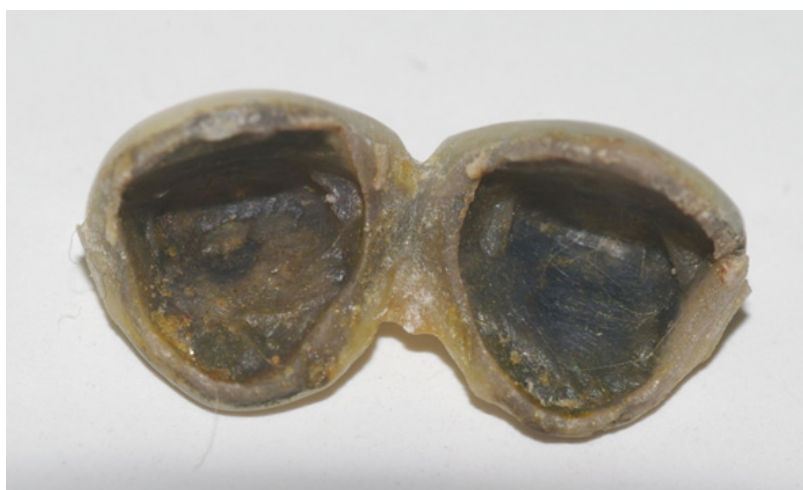
**Figure 3:** Intaglio surfaces of the crowns following removal. The margins appear irregular and uneven. The two crowns were splinted together.

The original crowns had been splinted together, possibly to compensate for the inadequate retention of the preparations. In addition, the visibility of the metal copings through the veneering porcelain suggests inadequate porcelain thickness or insufficient support of the veneering ceramic during laboratory fabrication.

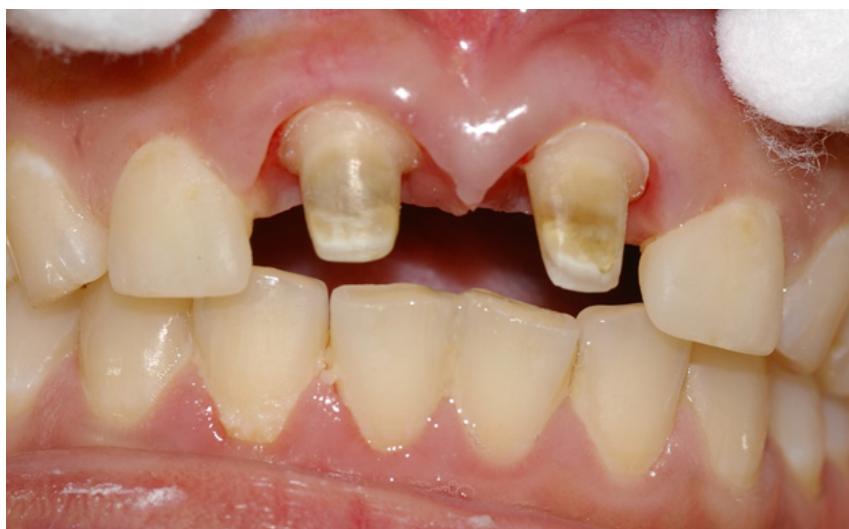
**Figure 4:** Using a tapered diamond bur in a high-speed handpiece, the axial walls were redesigned and the finish line was redefined and repositioned slightly subgingival. The axial walls were modified to achieve near-parallelism, thereby optimizing mechanical retention. The preparations were refined. In addition, the mesial aspects of the maxillary lateral incisors were augmented with resin composite to increase their apparent width and improve proportional harmony. Healing of the gingival tissues can be observed in this image, which was taken two weeks after removal of the original defective crowns and placement of properly fitted provisional crowns.

Following administration of a local anaesthesia, both crowns were removed simultaneously with relative ease using a manual crown remover. The two crowns came out as one piece. After removal, it was noted that the two incisors' preparations exhibited an unusual rough semilunar configuration Figure 2. The preparations lacked essential retention features, including near-parallelism of the axial walls and adequate occlusogingival height. In addition, the lingual finish lines were irregular and required re-establishment. The removed crowns were found to be splinted together at the midline and had ragged margins Figure 3. The axial walls of the two crown preparations were carefully altered using medium grit tapered diamond burs (Brasseler, USA) at high-speed with copious water cooling. As a result, the preparations were reshaped at the proximal aspects to establish proper length and angulation for optimum retention. The lingual surfaces of the teeth were refined with a medium-grit football diamond bur (Brasseler, USA) Figure 4.

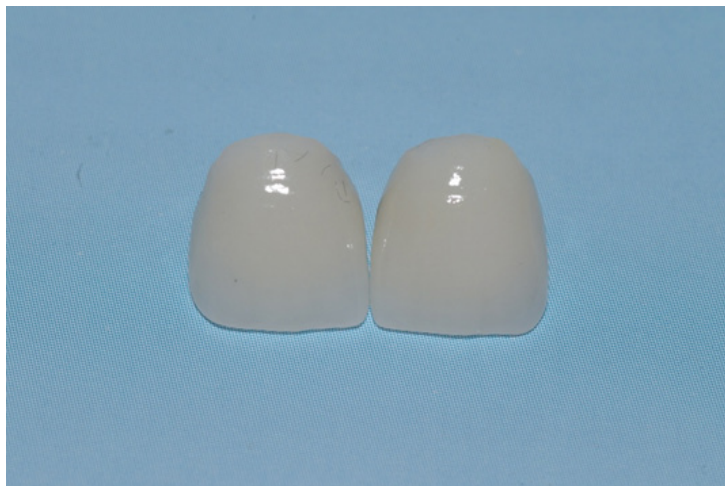
**Figure 5:** At a commercial dental laboratory, two lithium disilicate glass ceramic crowns were made. They were monolithic and milled out of IPS e. Max blocks (Ivoclar-Vivadent).

Two monolithic fully crystallized lithium disilicate glass-ceramic crowns (IPS e. Max, Ivo Clar/Vivadent, USA) were subsequently fabricated at a commercial dental laboratory Figure 5.

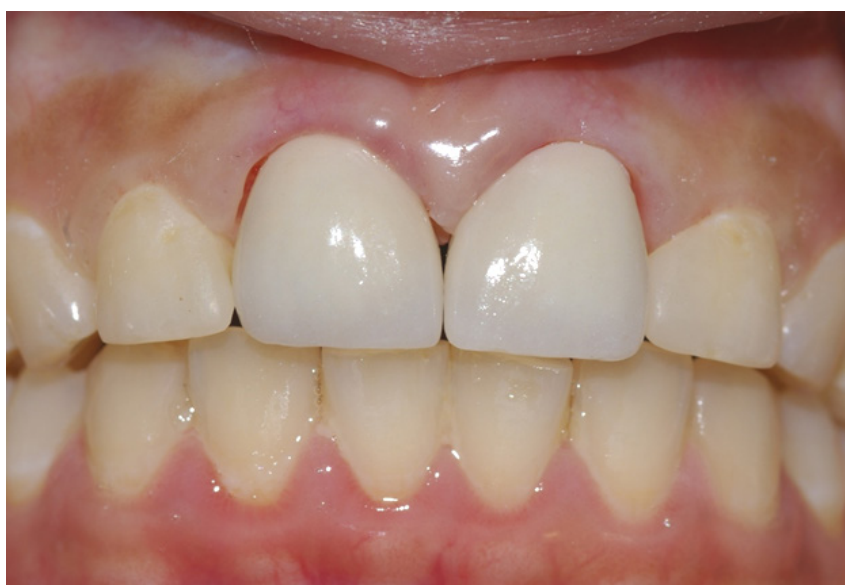
**Figure 6:** The two fabricated crowns at try in stage. While they appear lighter in colour than the rest of the teeth, the patient had planned to whiten her teeth later.

At the insertion appointment, the temporary crowns were removed and the tooth surfaces were cleaned first with a slurry of pumice in a rubber cup, then with Ivo clean (Ivo Clar/Vivadent, USA). The crowns were then evaluated intraorally for fit and colour Figure 6. Although the shade appeared slightly lighter than the adjacent teeth, this discrepancy was expected to diminish once the patient completed the planned tooth-whitening treatment. The crowns were then definitively cemented using a dual-polymerized resin cement (Panavia SA Cement Universal, Kuraray Noritake, Japan), a reliable resin cement [17] Figure 7.

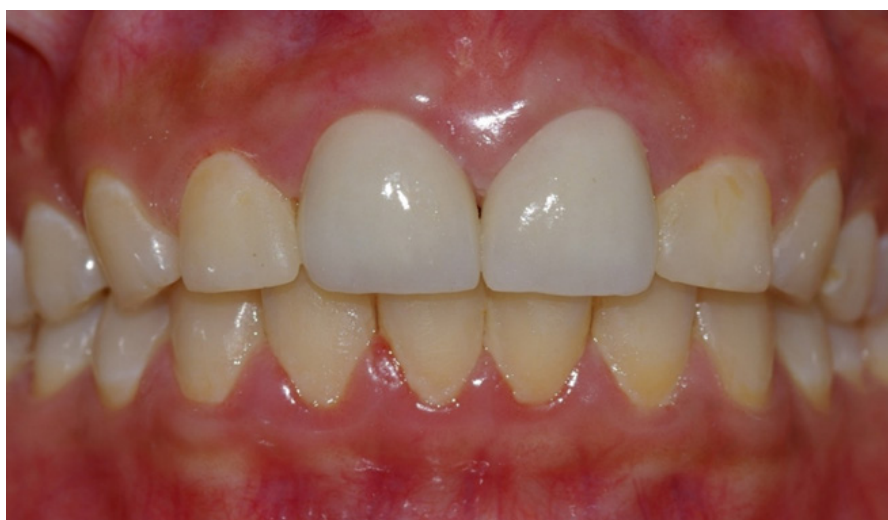
**Figure 7:** Two weeks after insertion, the gingival tissues at the crown margins appear to be healing well. Compared with the pretreatment image, a significant aesthetic improvement can be observed.
